Reduction and Mitigation of Thermal Injuries; What Can be Done

**Joel J. Voisine
and
John P. Albano**

January 1996

**U.S. Army Aeromedical Research Laboratory
Fort Rucker, Alabama 36362-0577**

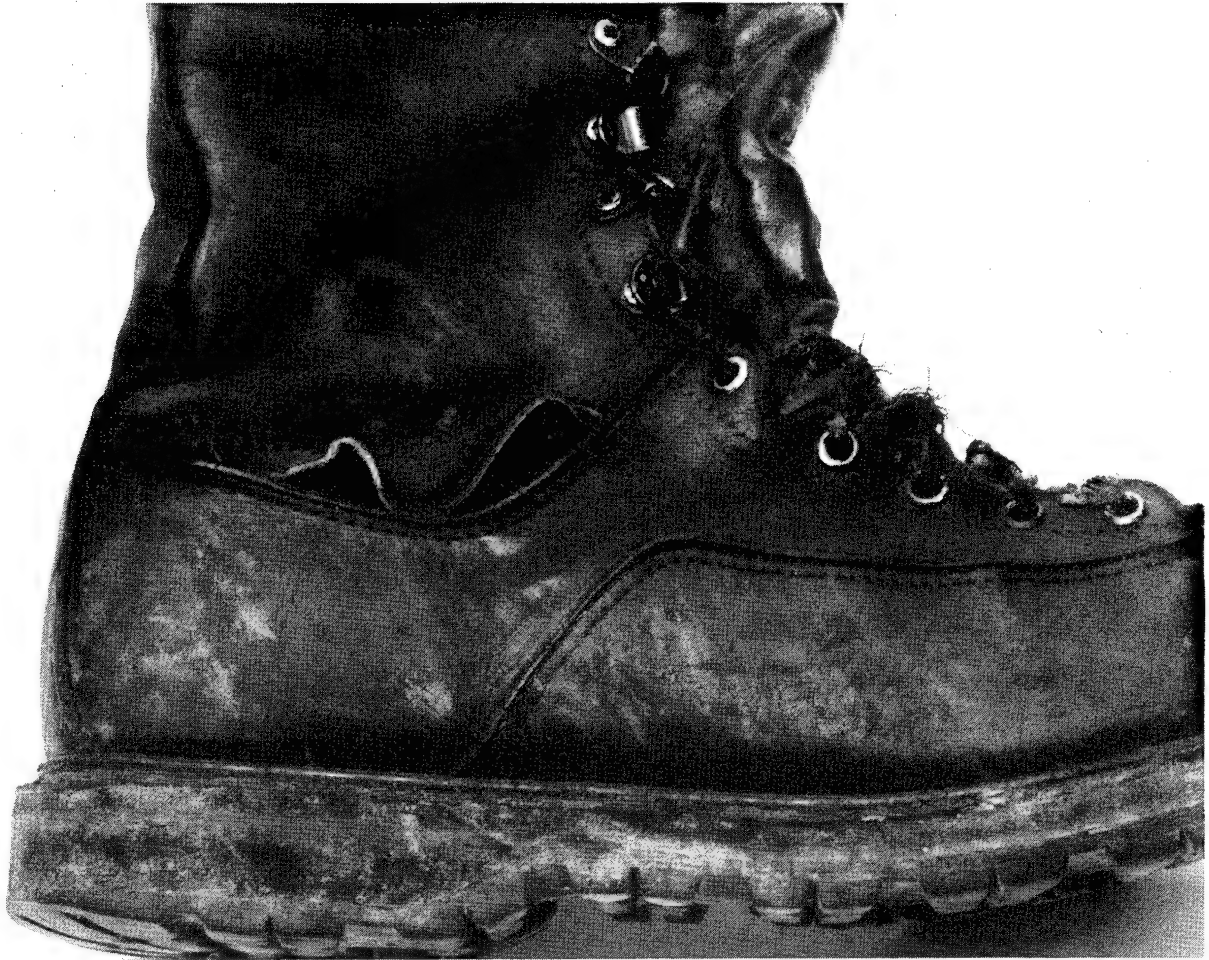
Figure 1. All leather boots provided 100% protection even when stitching burned and the seam failed.

The pilot was wearing leather boots, serviceable Nomex® flight suit, gloves, and jacket (with collar up) and helmet. Although on fire when he egressed, the ensemble worked as designed and the flame extinguished (Table 3).⁶ The flight jacket collar and right shoulder burned through the outer layer, but protected him from thermal injury. The stitching on his right boot burned through revealing the inner Gore Tex™ liner, yet protected his feet from injury (Figure 1). He received minor thermal injuries.

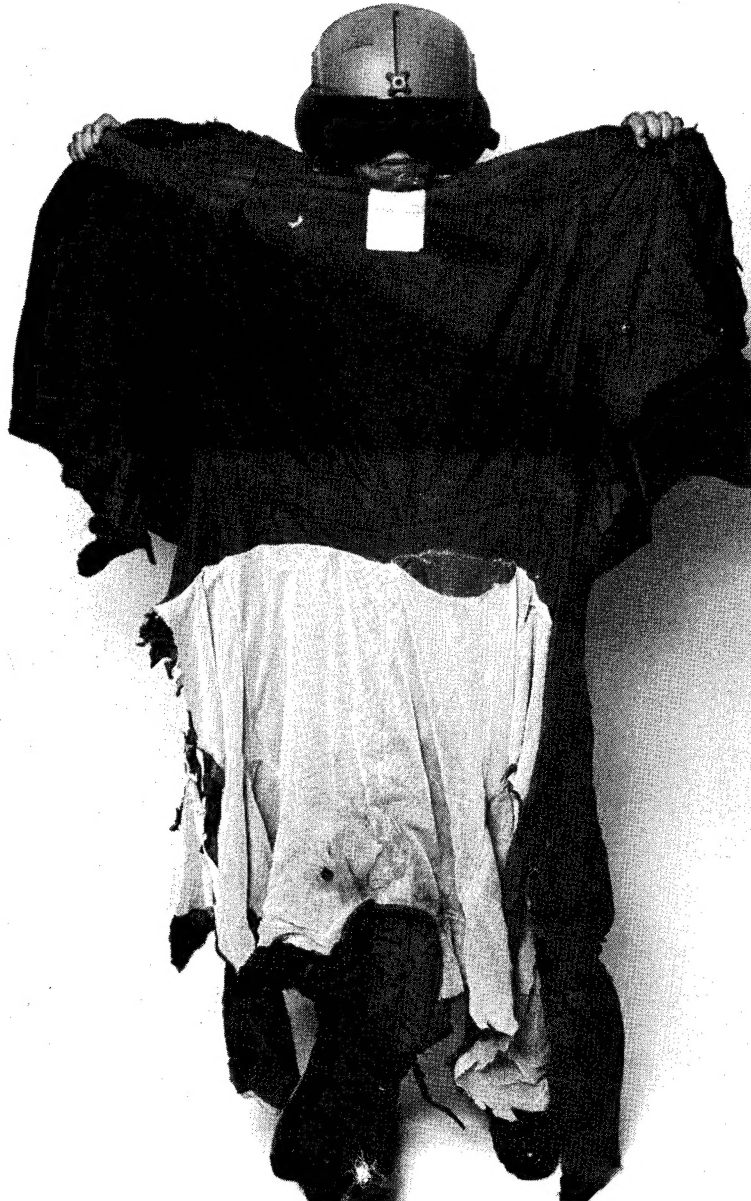
Figure 3. Nylon coveralls worn as an undergarment melted to the flight suit and the individual from the waist down.

The copilot egressed shortly after the pilot. He was wearing gloves with holes in numerous finger tips (Figure 2). As a result, the burns he received to his right hand caused permanent impairment. He also was wearing an Air Force approved flying coverall under his Nomex® flight suit. This Air Force item was not authorized by the Army for aviation use because it had a nylon lining. Where the coverall was covered by both the flight suit and flight jacket, it did not melt or burn. From the waist down, however, the heat and fire melted the coverall into the flight suit and the individual (Figure 3). The thermal injuries this individual received on his legs resulted in his disqualification from aviation and military duties.

It is clear from the case reports that when aviation personnel involved in fire mishaps dressed in violation of AR 95-1, injuries resulted. Had the copilot in Case 1 worn serviceable gloves, it is doubtful that he would have sustained the extensive burns to his hand. Had he not worn the nylon overall, his leg injuries would not have been severe enough to end his military and flying career. In Case 2, had the pilot worn leather boots, they would have provided the protection necessary to avoid the lower leg injuries he suffered. Had the copilot in Case 3 worn cotton or wool underwear as directed by regulations, his injuries would have been significantly reduced.

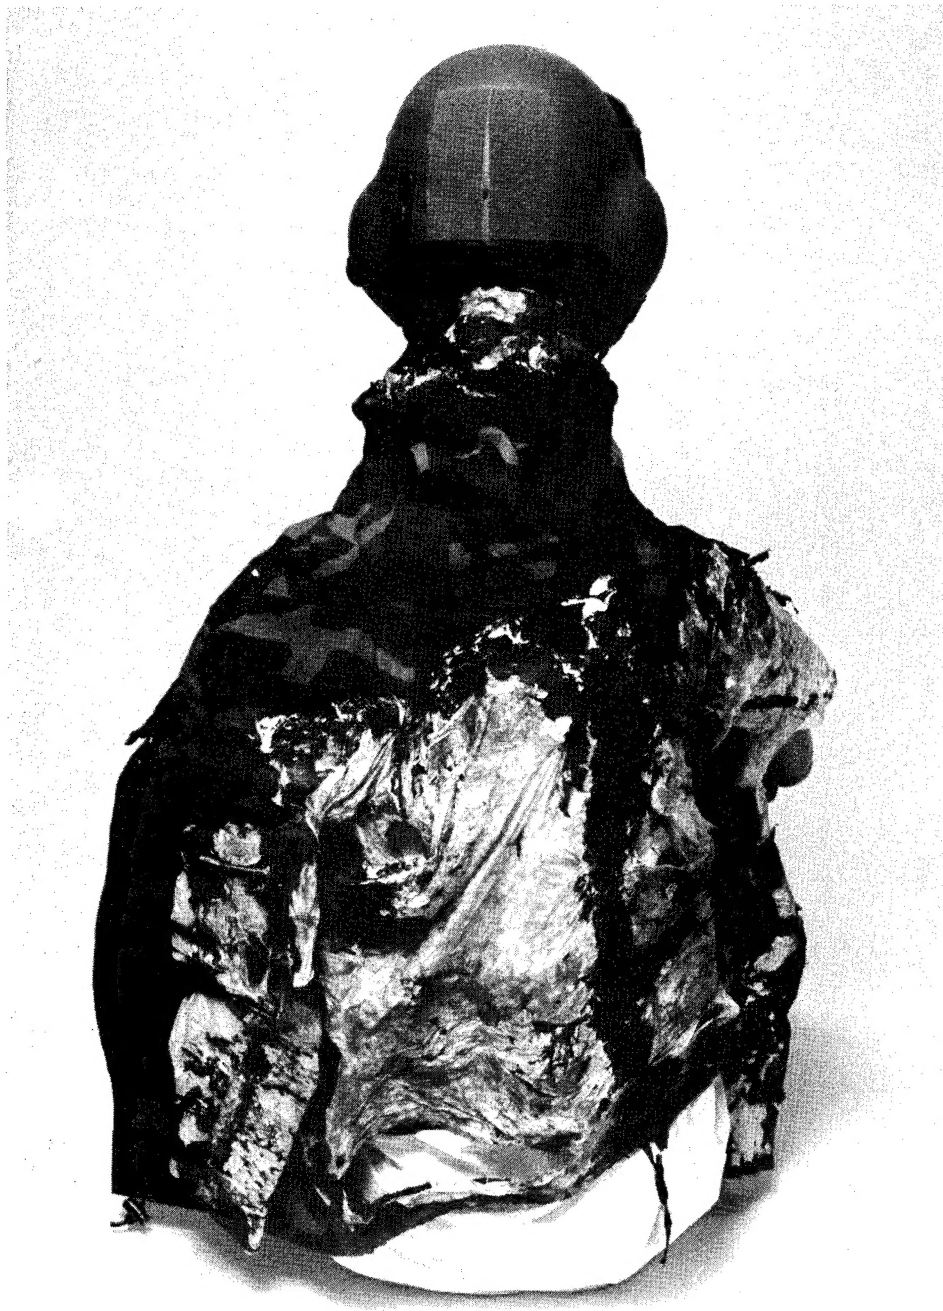
Figure 4. The Gore Tex™ field jacket, an item of issue, performed poorly in a fire as the inner and outer nylon shell melted to the individual.

One passenger egressed successfully only to return into the blaze to assist another passenger. He was wearing a battle dress uniform (BDU) and a Gore Tex™ field jacket (Figure 4). The Gore Tex™ material did not contribute to injury, but the jacket's nylon inner and outer shell burned and melted into the fabric of his BDU and his skin. He received major thermal injuries.

The need to protect all soldiers from exposure to thermal injuries is equally as important as protecting aviation personnel. Passengers and soldiers in other occupations were not protected by AR 95-1. In Case 1, a passenger got severely burned because he wore an issued Gore Tex™ field jacket. By the same token, who ensures that personnel operating armored vehicles aren't wearing the jacket over the Nomex® tanker's uniform?
